VEHICLE INSPECTION REPORT

HX65UZF

Mercedes-Benz Sprinter 513 CDI

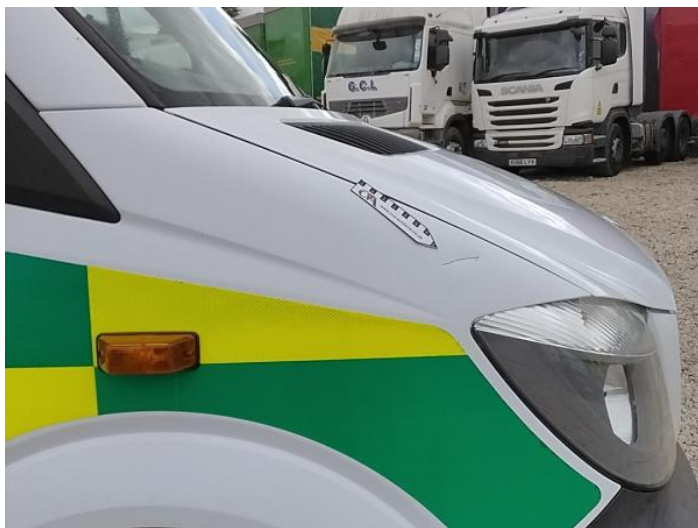
1: Wing of
Scratched
Over 25mm Thru Paint

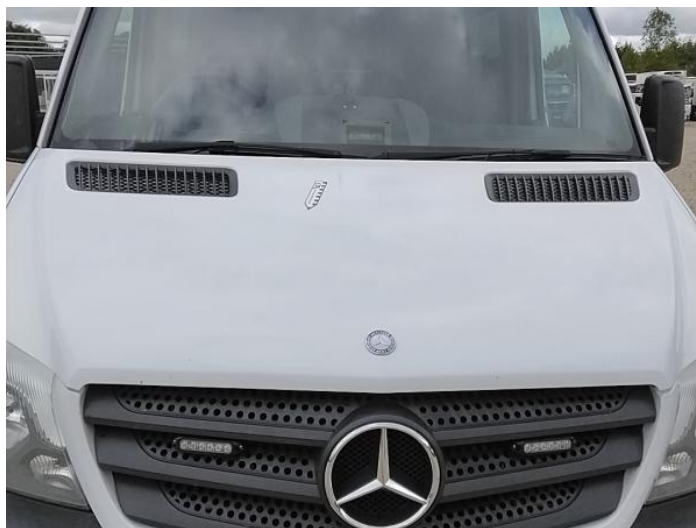
2: Bonnet
Chipped
Multiple Chips

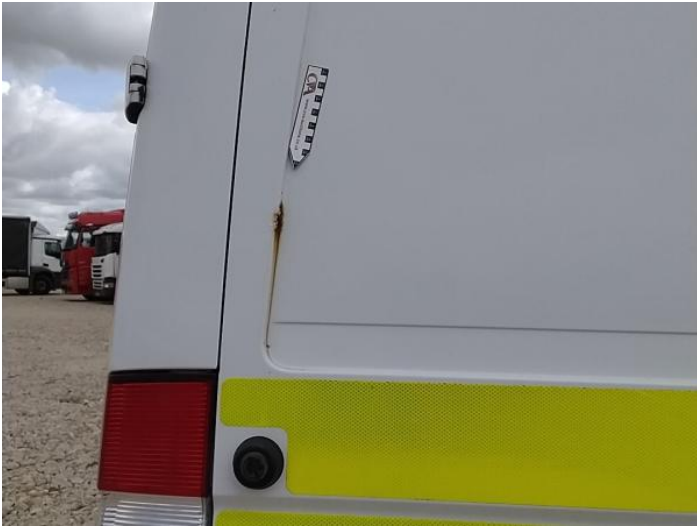
3: Qtr Panel osr
Rusted
Over 5mm

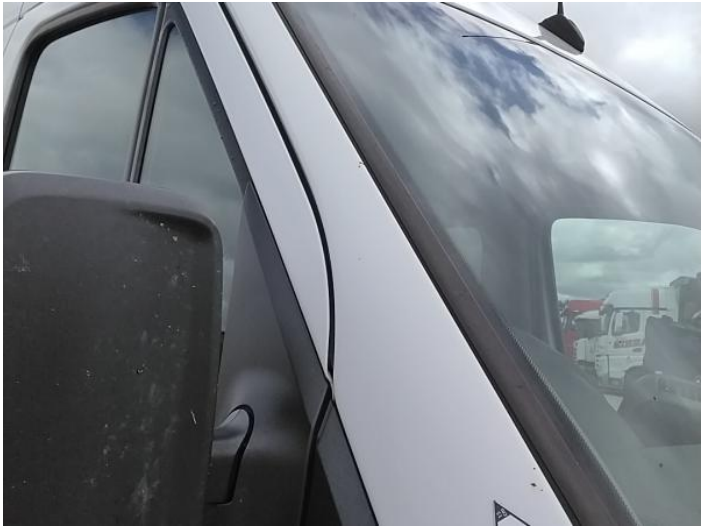
4: A Post os
Chipped
Multiple Chips

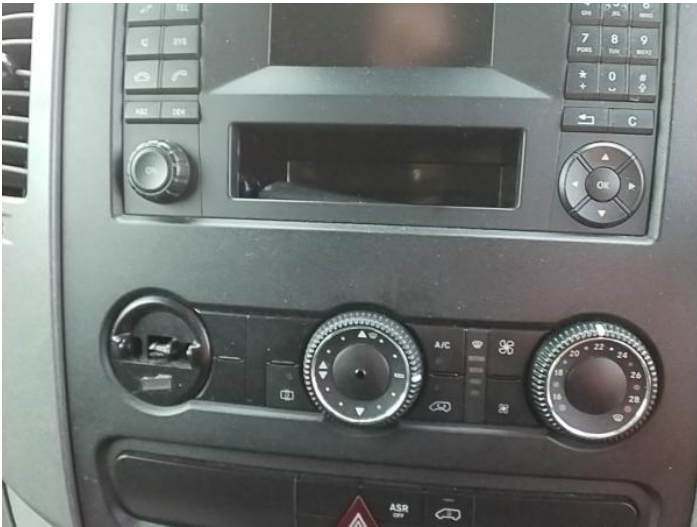
5: Switches And Controls
Broken
Replace
