VEHICLE INSPECTION REPORT

PE63NLR

Daf LF 45.140

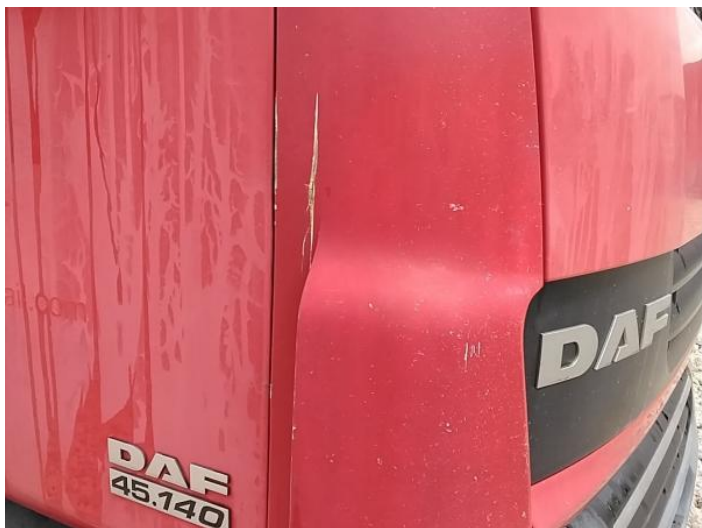
1: Wing osf
Scratched
Over 25mm Thru Paint

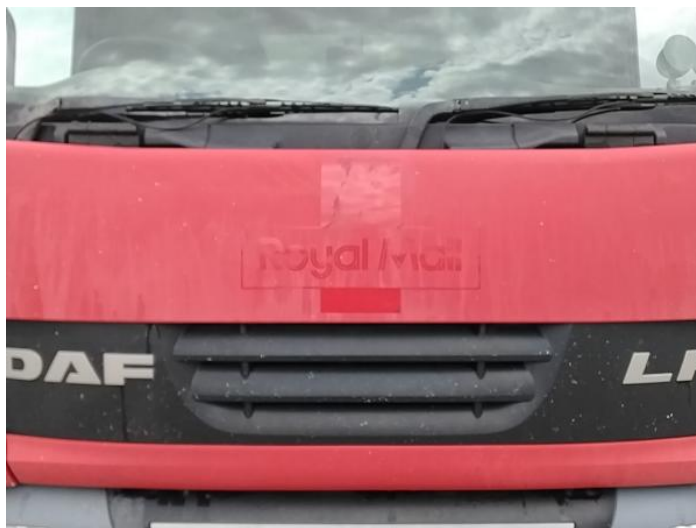
2: Bonnet
Chipped
Multiple Chips

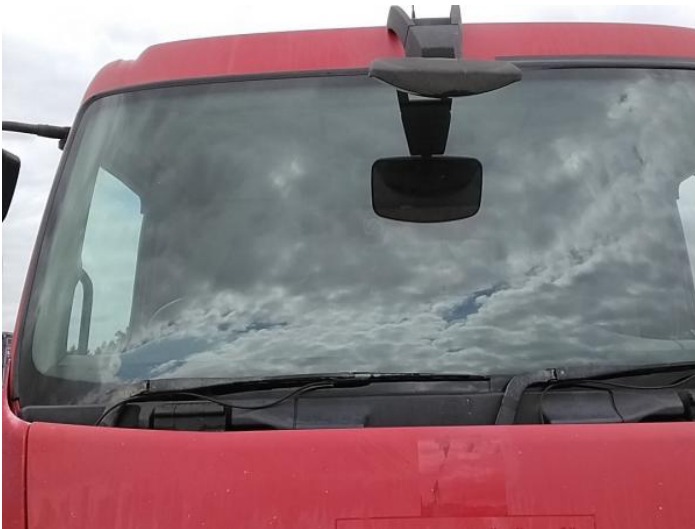
3: Screen Front
Chipped
UpTo 10mm

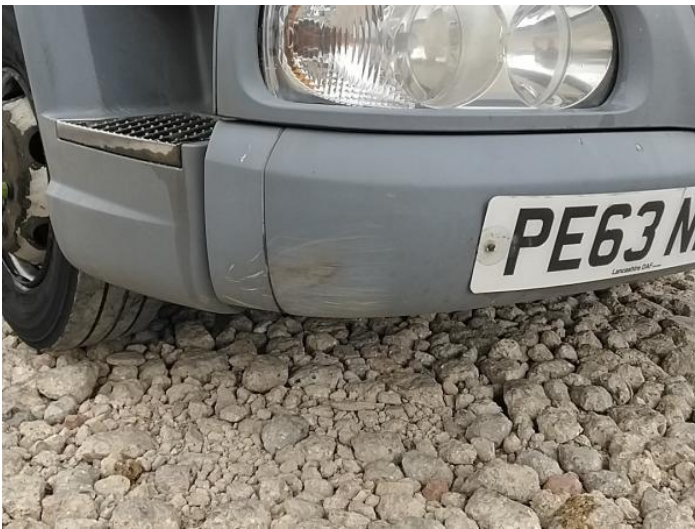
5: Bumper Front Moulding
Scuffed (Unpainted)
UpTo 100mm

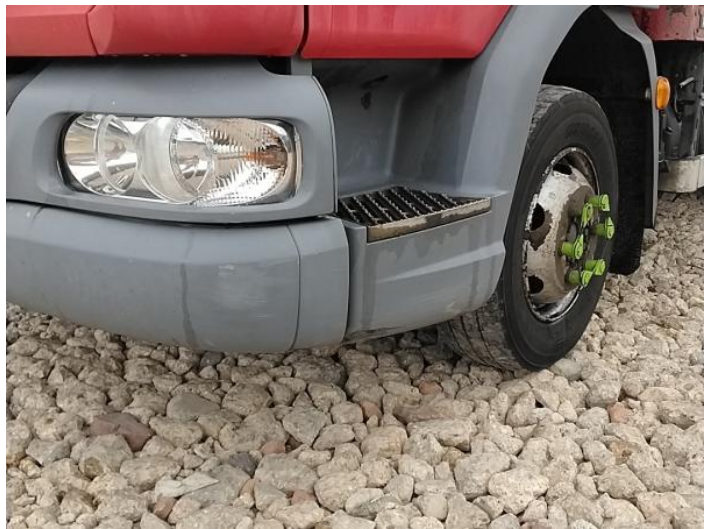
6: Bumper Front Moulding
Scuffed (Unpainted)
UpTo 100mm

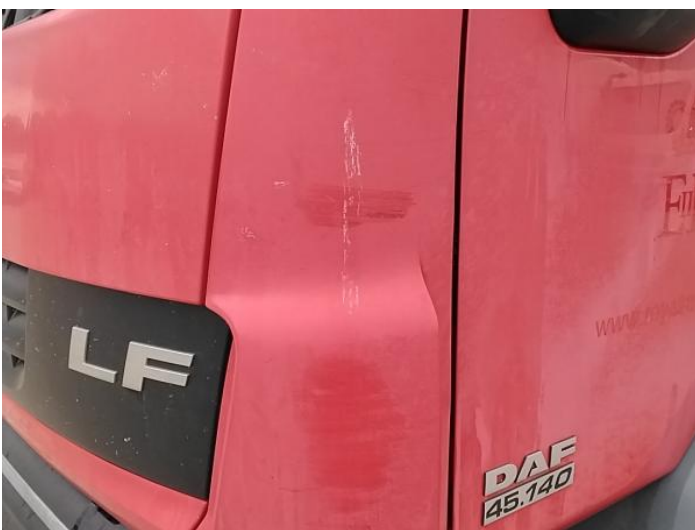
7: Wing nsf
Scratched
UpTo 25mm Not Thru Paint

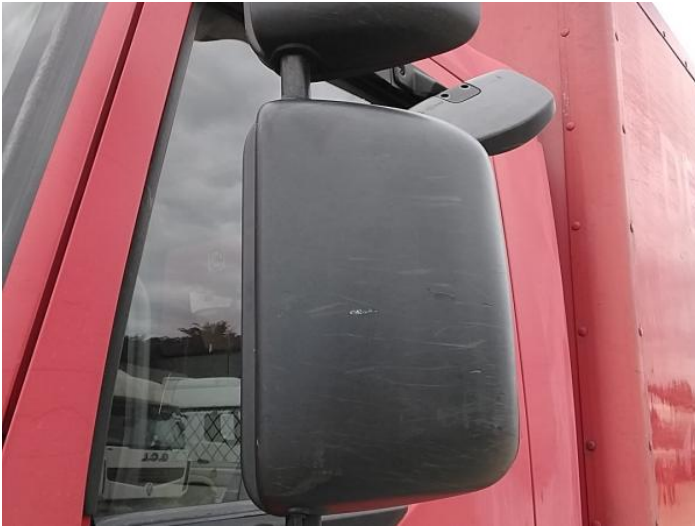
9: Door Mirror Assy nsf
Scuffed (Unpainted)
UpTo 100mm

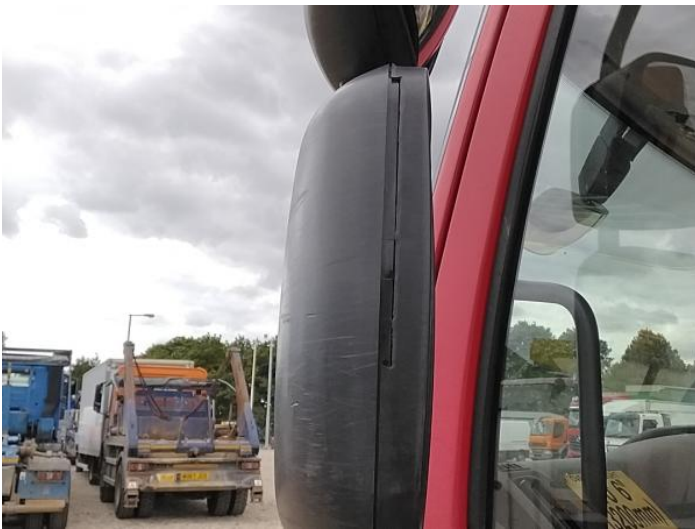
11: Door Mirror Assy nsf
Broken
Replace

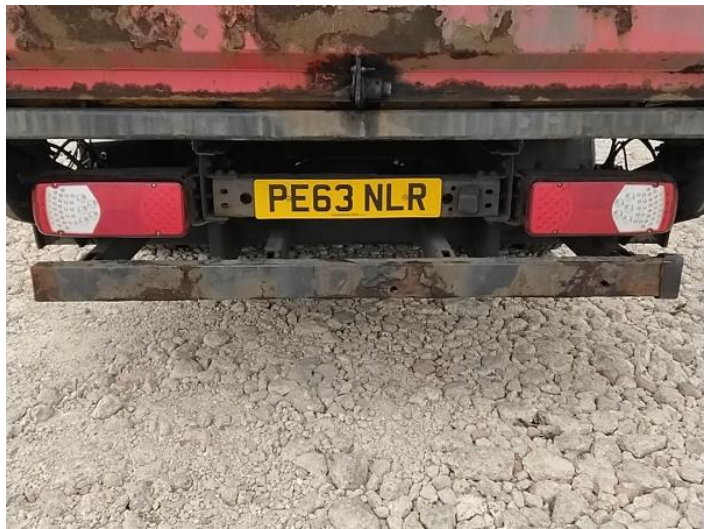
12: Bumper Rear
Rusted
Holed

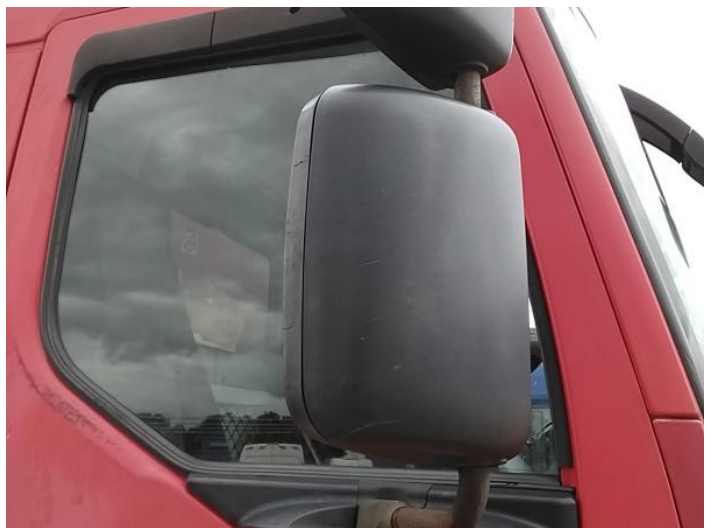
14: Door Mirror Assy osf
Scuffed (Unpainted)
UpTo 100mm

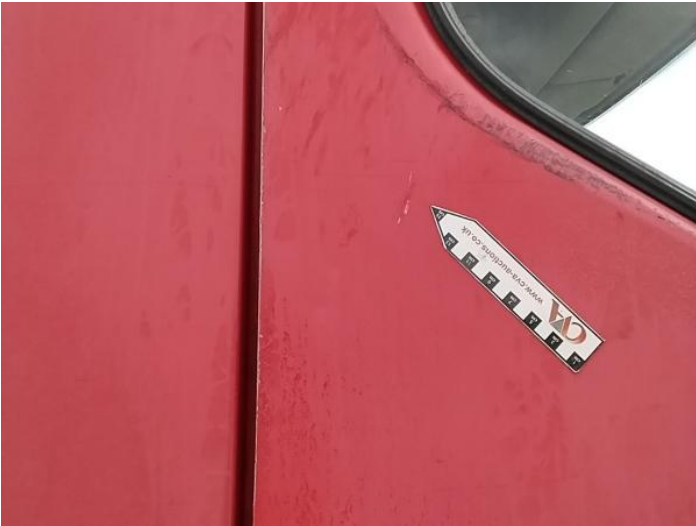
15: Door osf
Scratched
UpTo 25mm Thru Paint

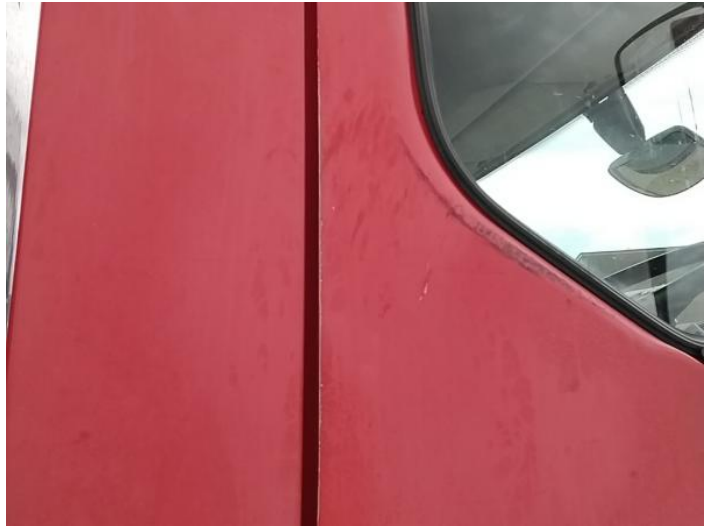
16: Door osf
Chipped
Edge Chip

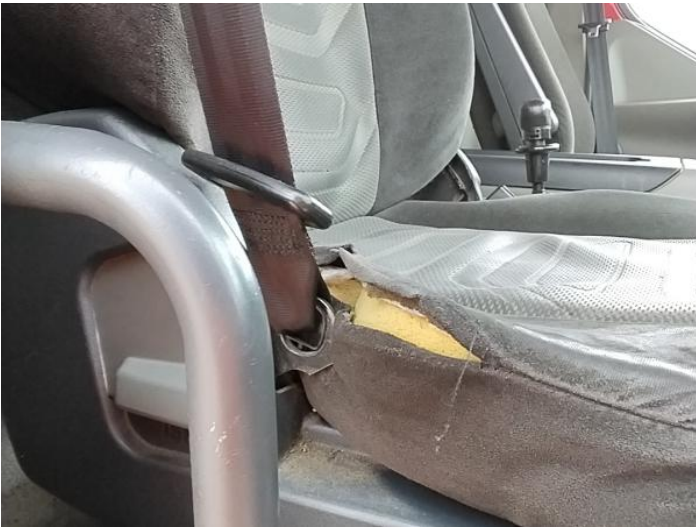
17: Seat Base Cover osf
Holed
Over 3mm

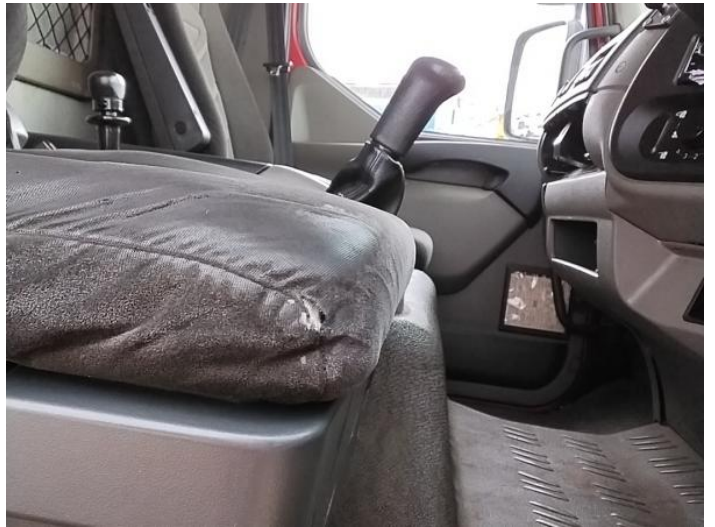
18: Seat Base Cover osf
Holed
Over 3mm

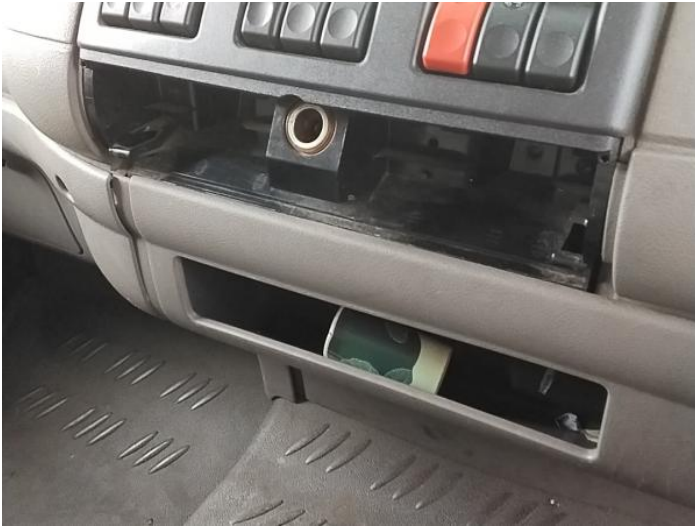
21: Fascia Panel
Missing
Replace
