## VEHICLE INSPECTION REPORT

**BX59DGO**

### Daf LF 45.160

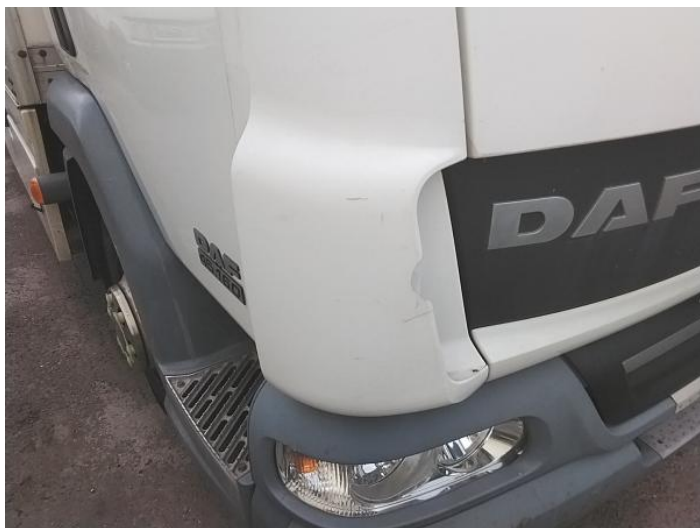
1: Panel Front  
Cracked  
Replace

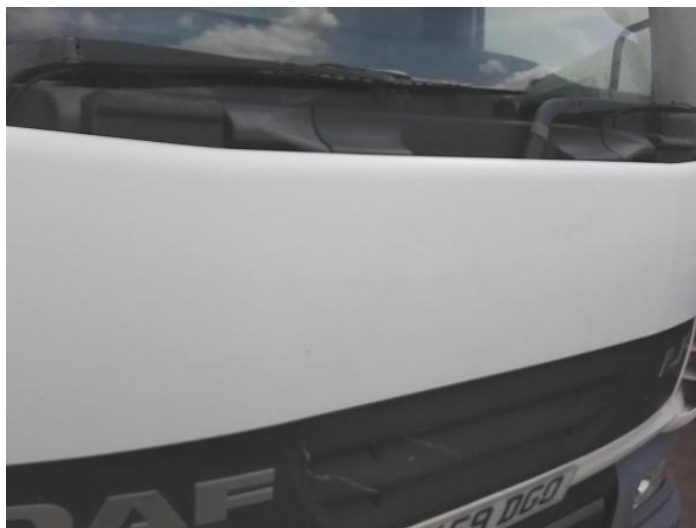
2: Bonnet  
Chipped  
Multiple Chips

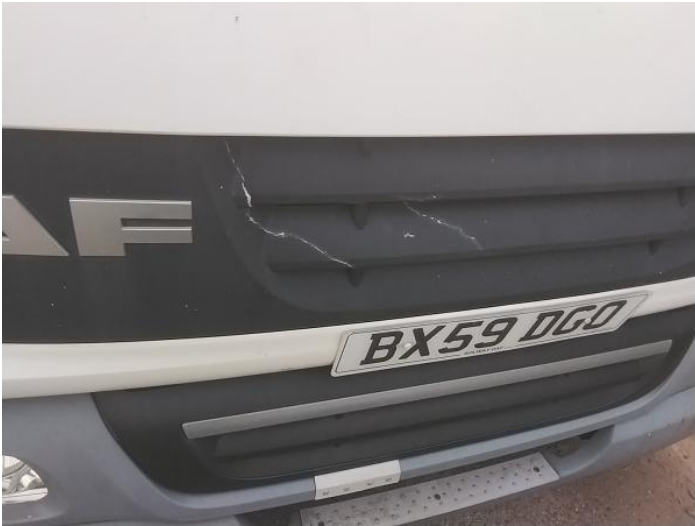
3: Bumper Front Grill  
Broken  
Replace

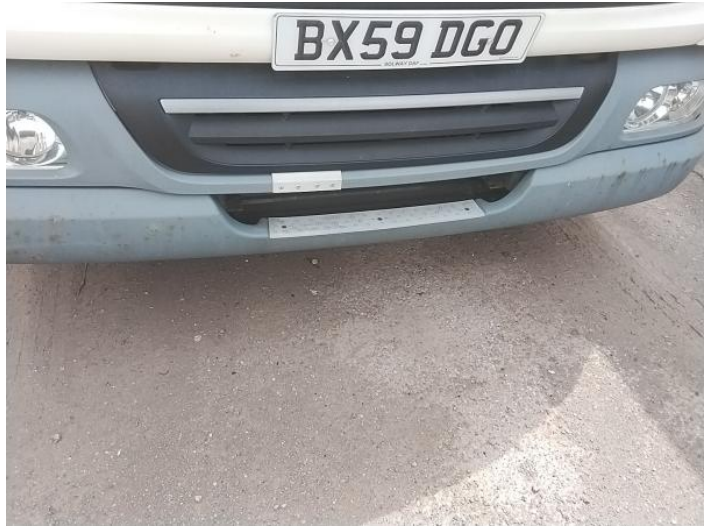
4: Bumper Front  
Rusted  
Over 5mm

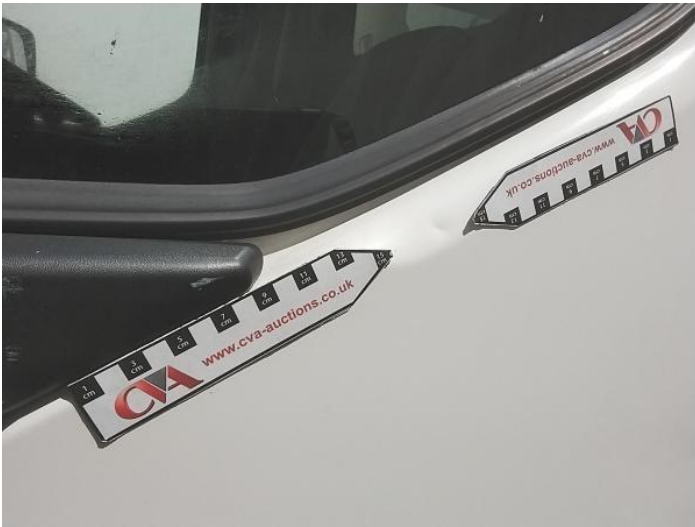
5: Door nsf  
Dented  
Over 30mm

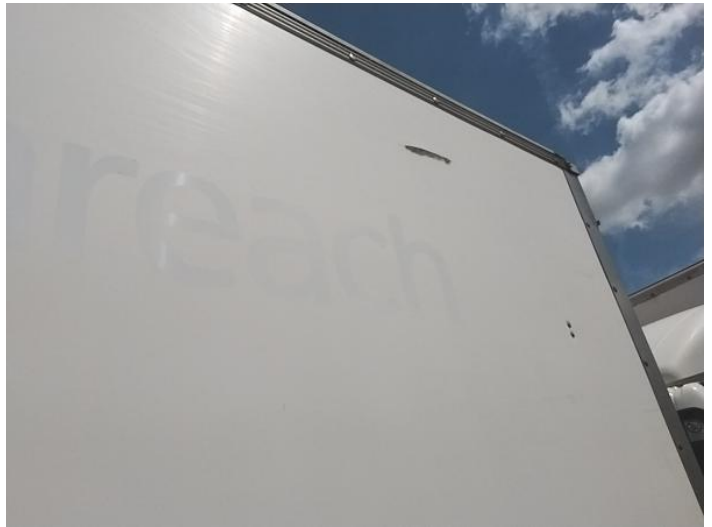
6: Qtr Panel nsr  
Scratched  
Over 25mm Thru Paint

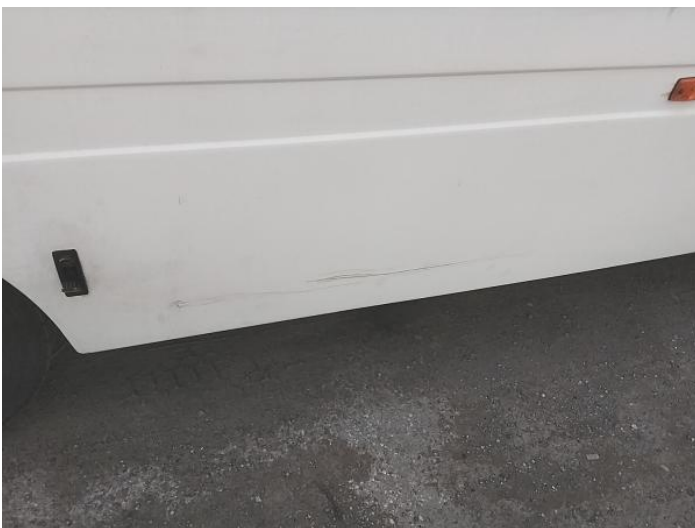
7: Qtr Panel Moulding os  
Broken  
Replace

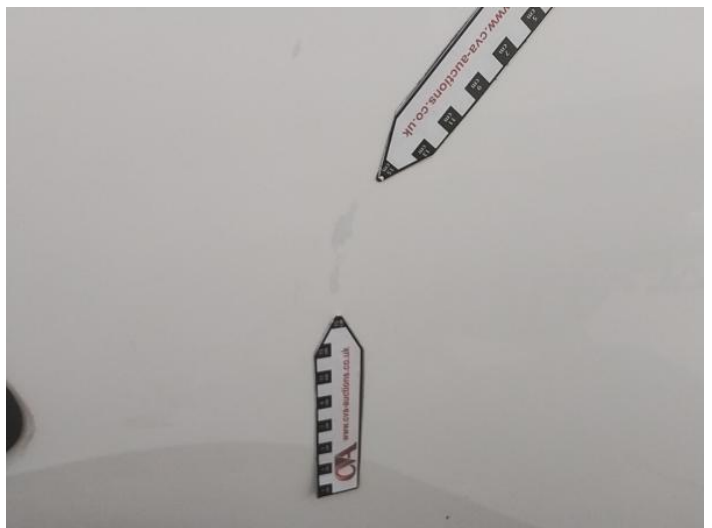
8: Door osf  
Scratched  
Over 25mm Thru Paint

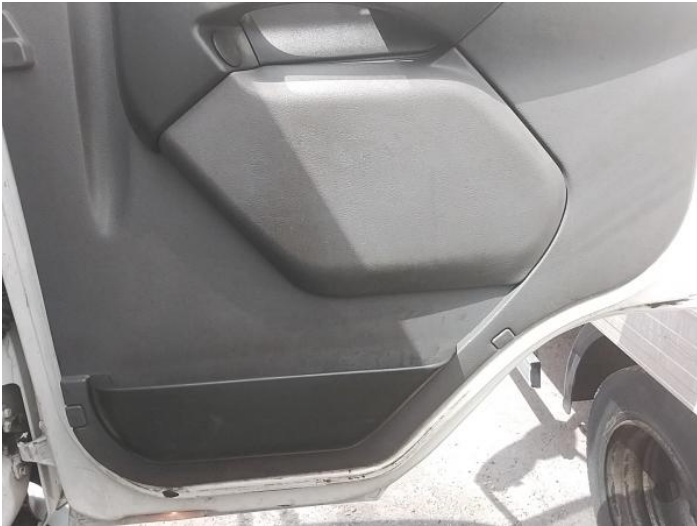
9: Door Pad osf  
Soiled  
Heavy

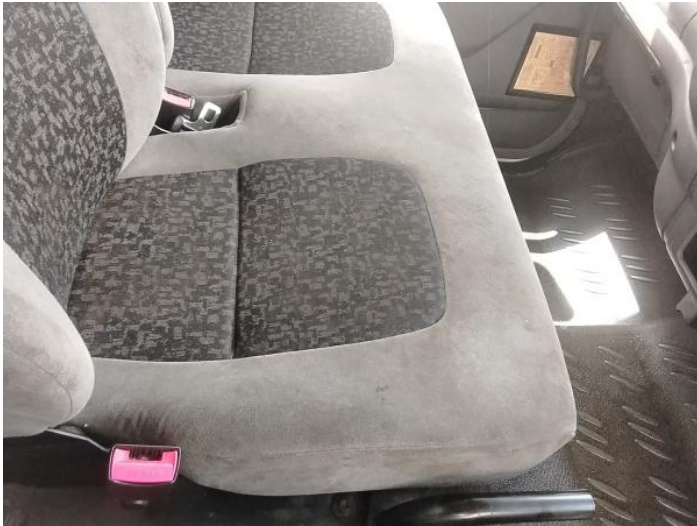
10: Seat Base Cover nsf  
Soiled  
Heavy

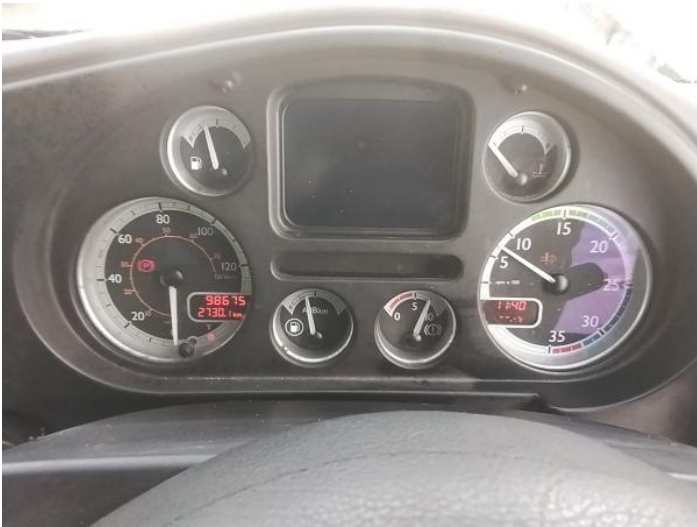
11: Dash Warning Lights  
Displayed  
No Action
