VEHICLE INSPECTION REPORT

YA70DBZ

Mercedes-Benz Sprinter 315 CDI PROGRESSIVE

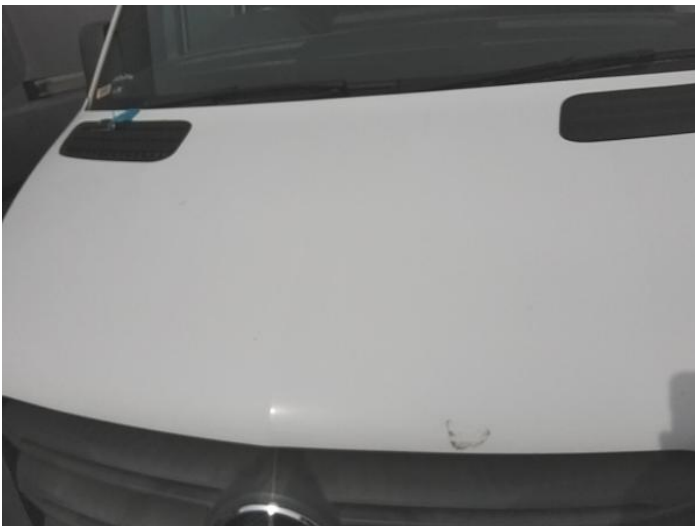
1: Bonnet
Chipped
Multiple Chips

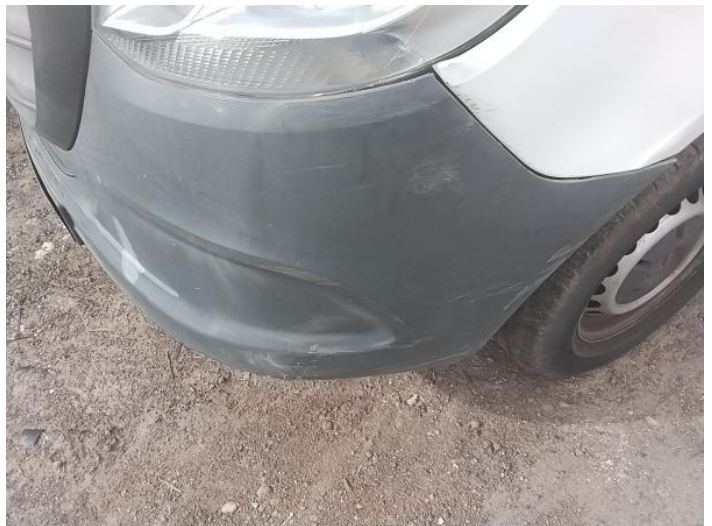
2: Bumper Front
Scratched
Over 100mm Thru Paint

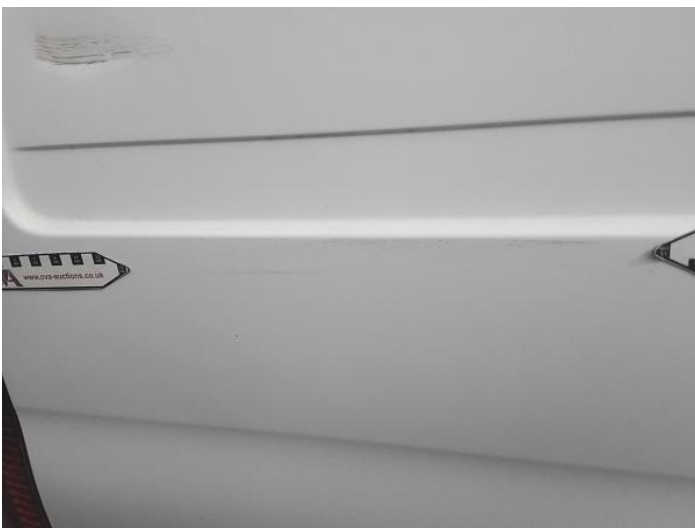
19: Qtr Panel osr
Scratched
Over 25mm Thru Paint

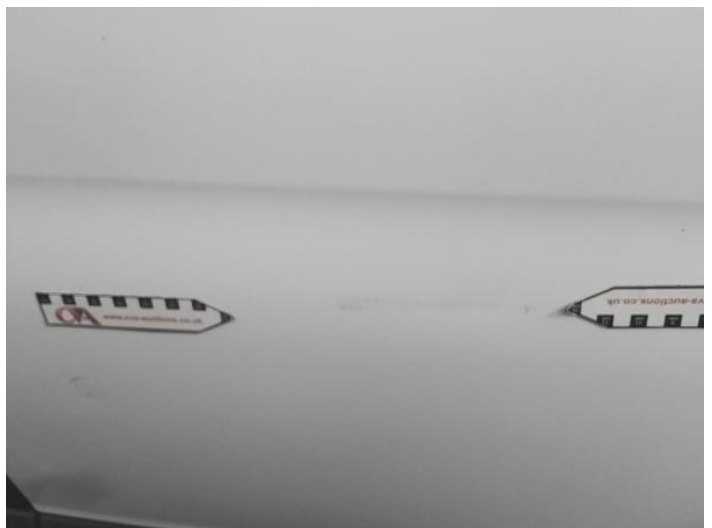
20: Qtr Panel osr
Dented
With Paint Damage

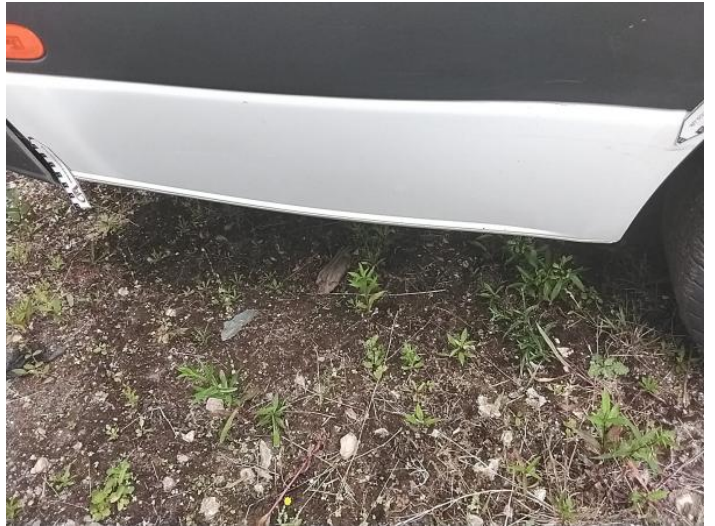
22: Qtr Panel osr
Scratched
Over 25mm Thru Paint

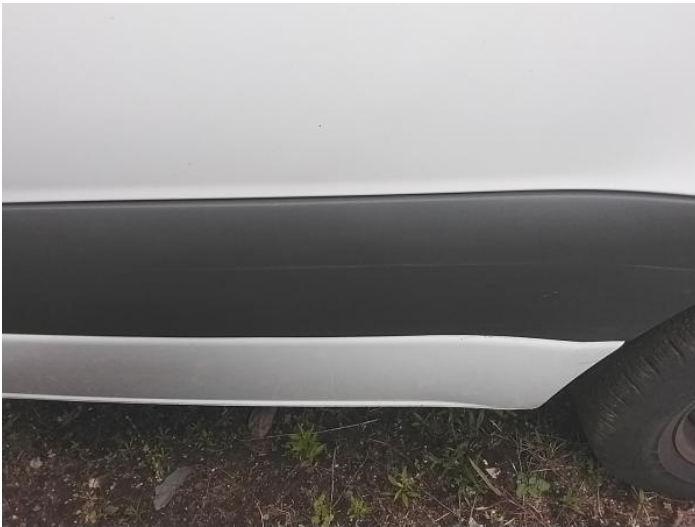
23: Qtr Panel Moulding os
Scuffed (Unpainted)
Over 100mm

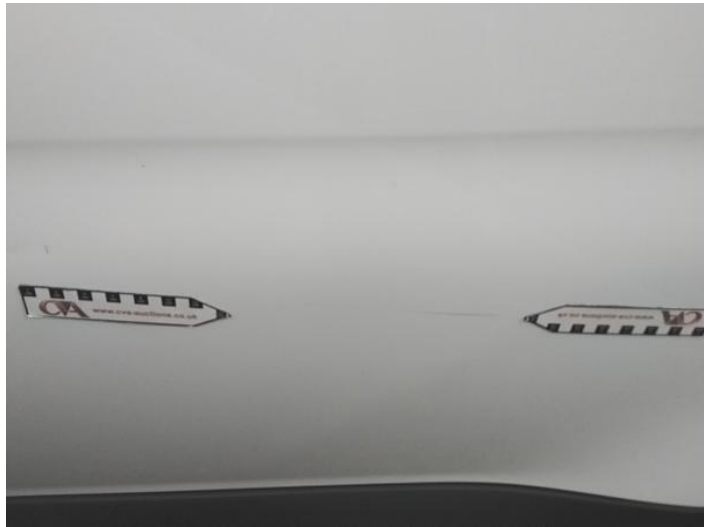
24: Qtr Panel osr
Scratched
Over 25mm Thru Paint

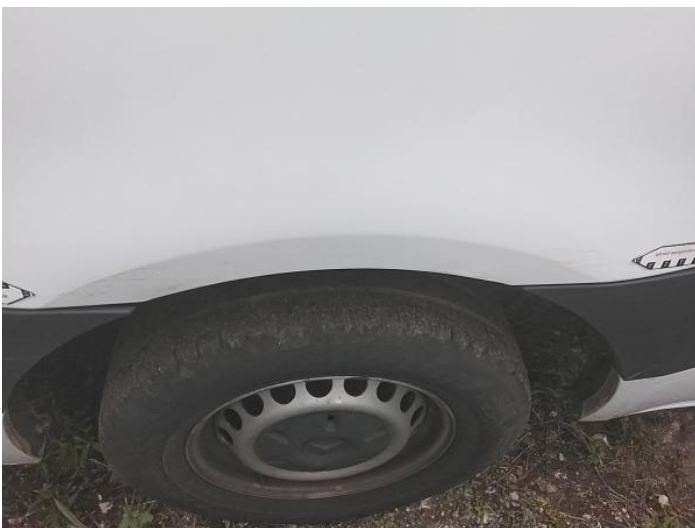
25: Qtr Panel osr
Scratched
Over 25mm Thru Paint

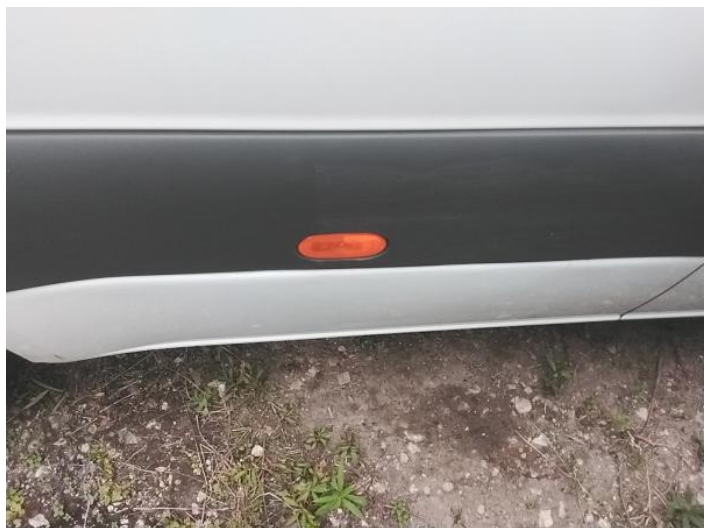
26: Qtr Panel Moulding os
Scuffed (Unpainted)
Over 100mm

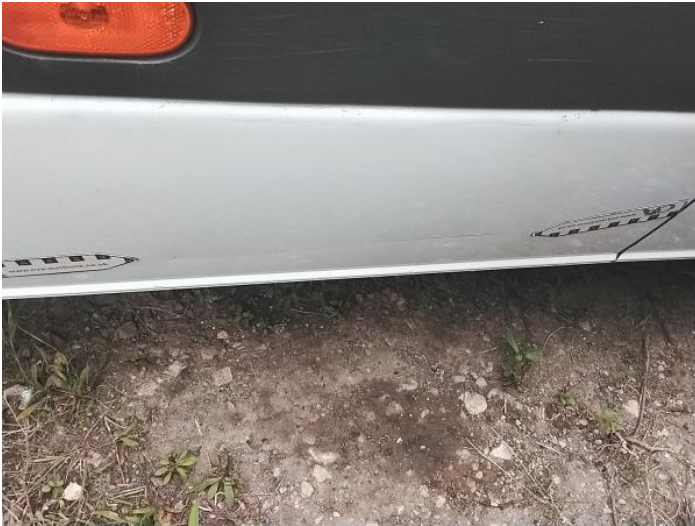
27: Qtr Panel osr
Dented
With Paint Damage

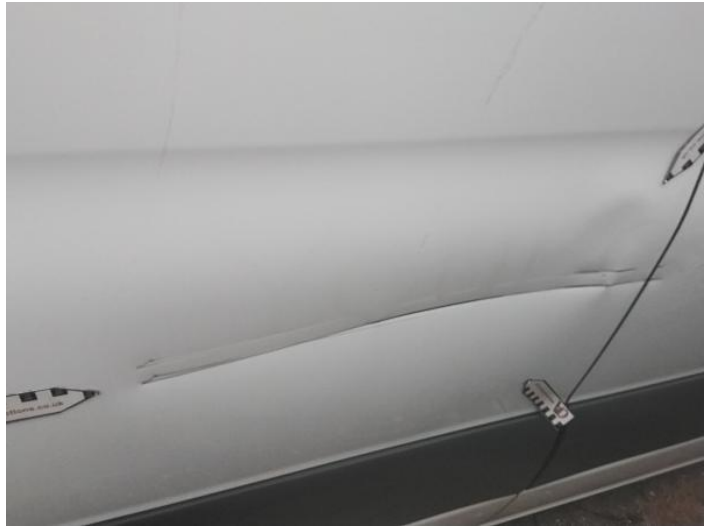
28: Qtr Panel osr
Dented
With Paint Damage

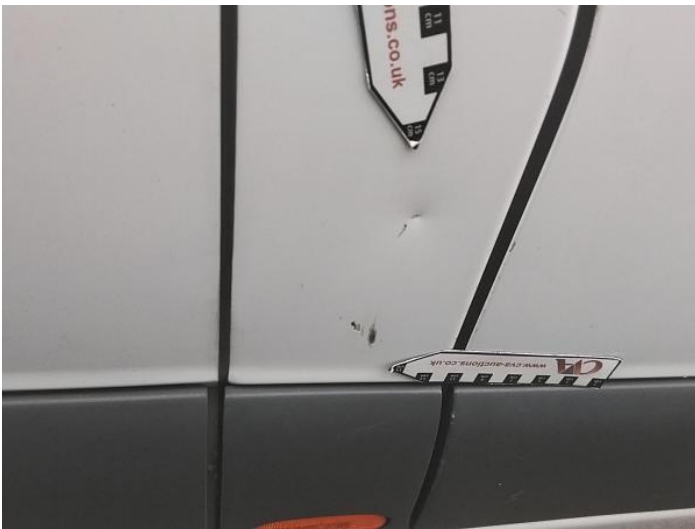
29: C Post os
Dented
With Paint Damage

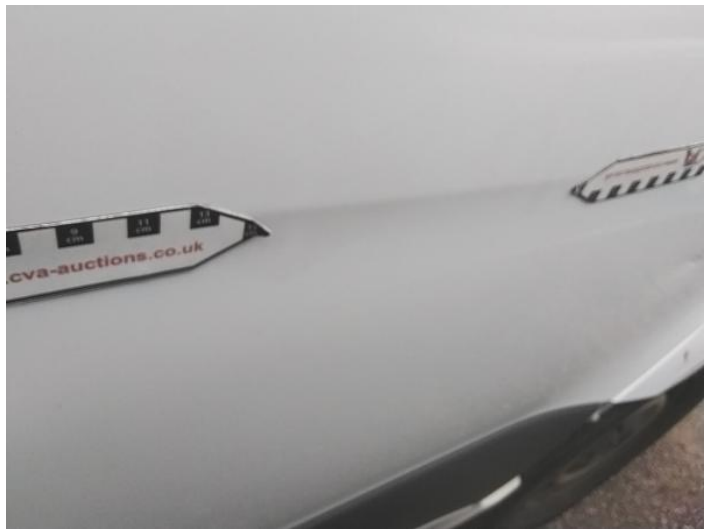
30: Door osf
Dented
Over 30mm

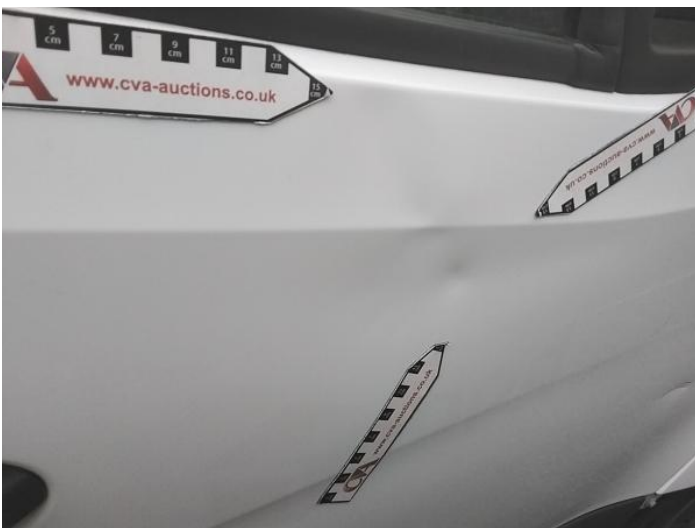
31: Door osf
Dented
Over 30mm

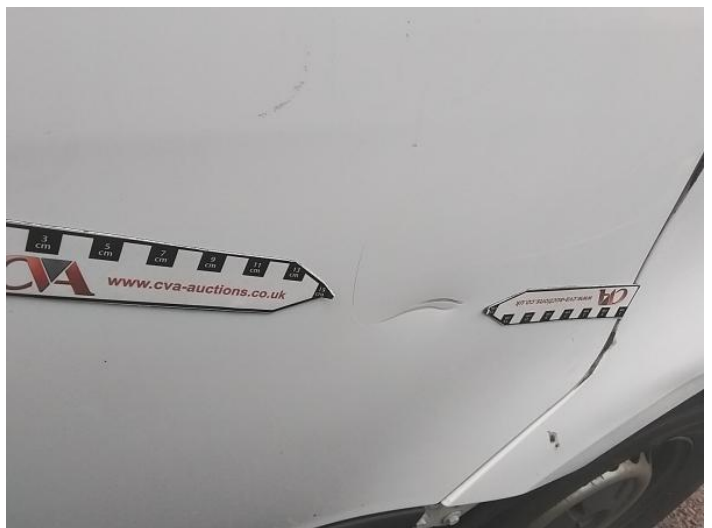
32: Door osf
Dented
With Paint Damage
