VEHICLE INSPECTION REPORT

PN18DBV

Iveco Daily 35-140

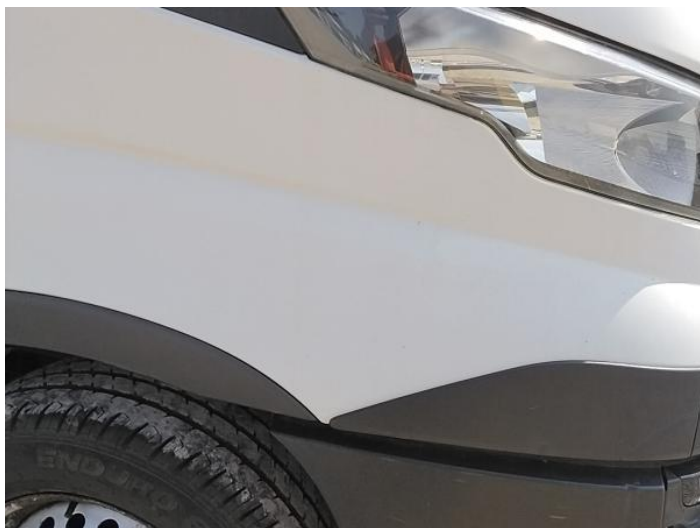
1: Wing of
Chipped
Multiple Chips

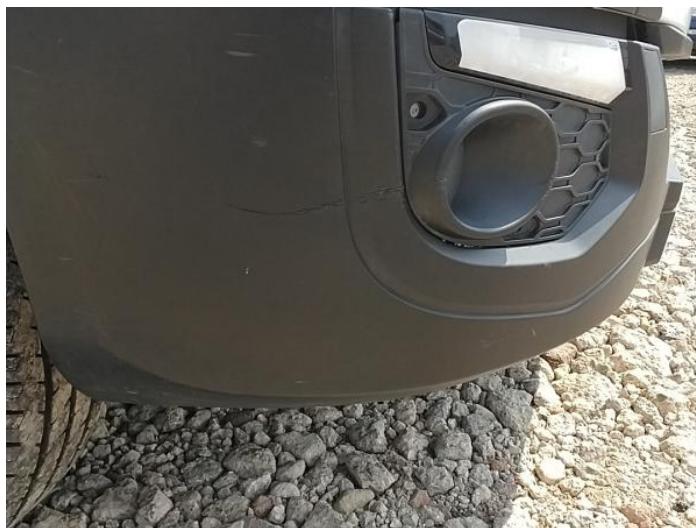
2: Bumper Front Moulding
Scuffed (Unpainted)
Up To 100mm

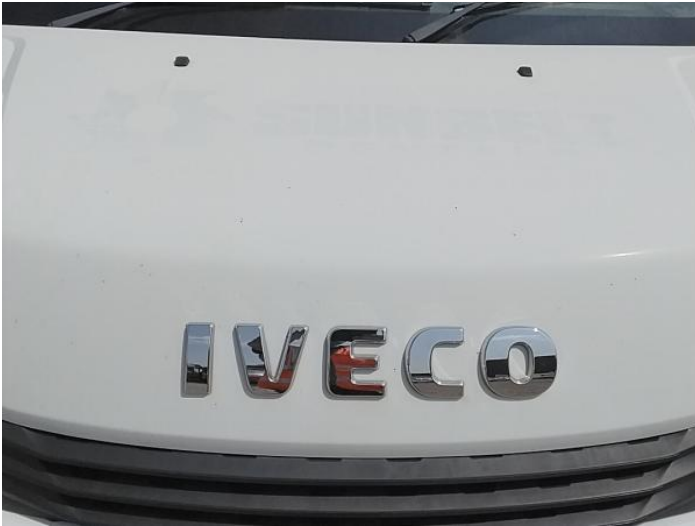
3: Bonnet
Chipped
Multiple Chips

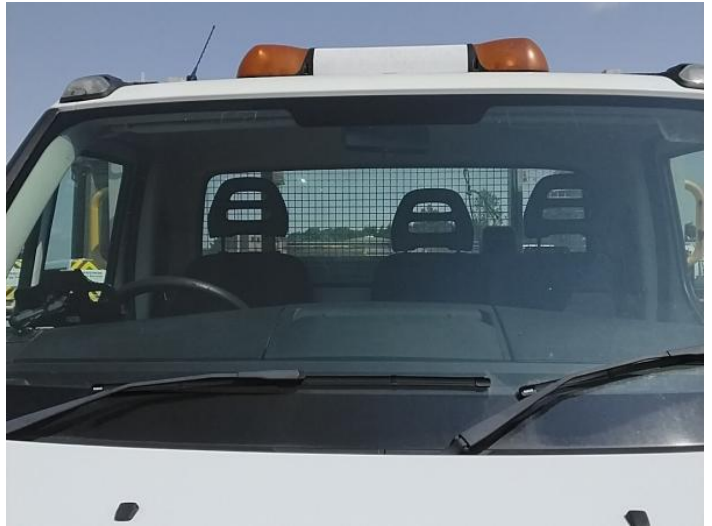
4: Screen Front
Chipped
UpTo 10mm

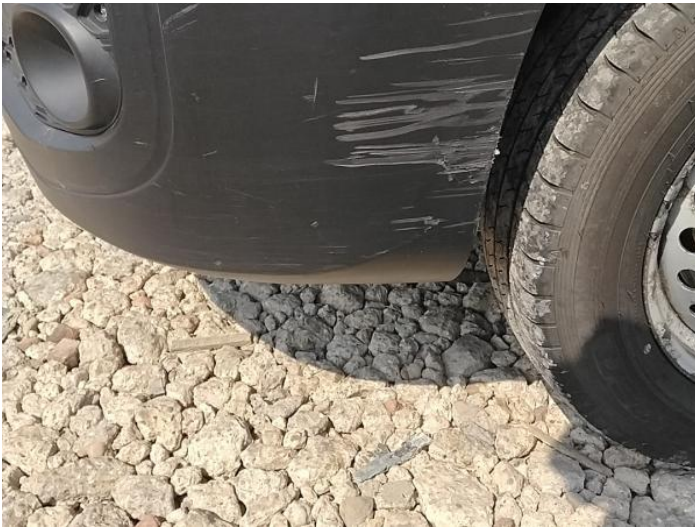
5: Bumper Front Moulding
Scuffed (Unpainted)
UpTo 100mm

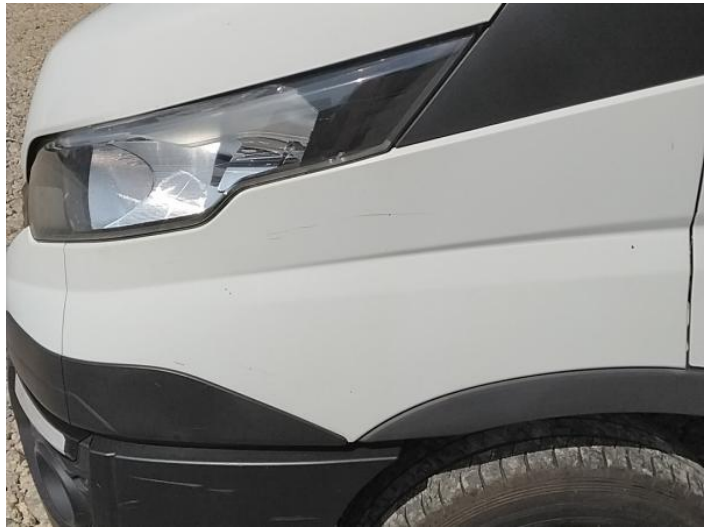
6: Wing nsf
Scratched
Over 25mm Thru Paint

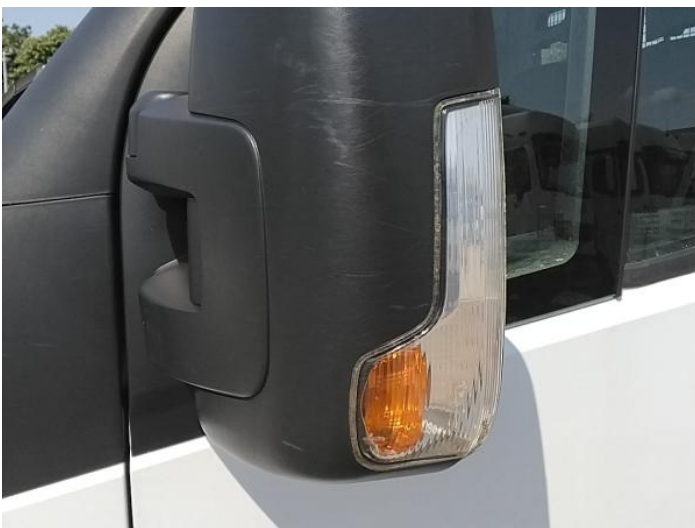
7: Door Mirror Assy nsf
Scuffed (Unpainted)
UpTo 100mm

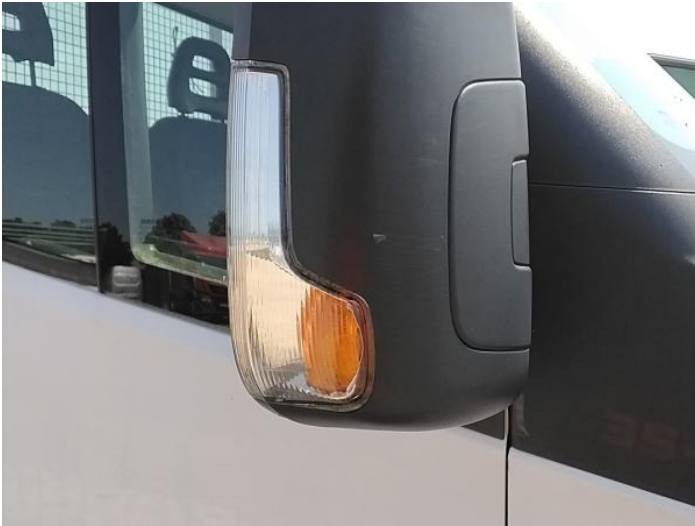
9: Door Mirror Assy osf
Scuffed (Unpainted)
UpTo 100mm

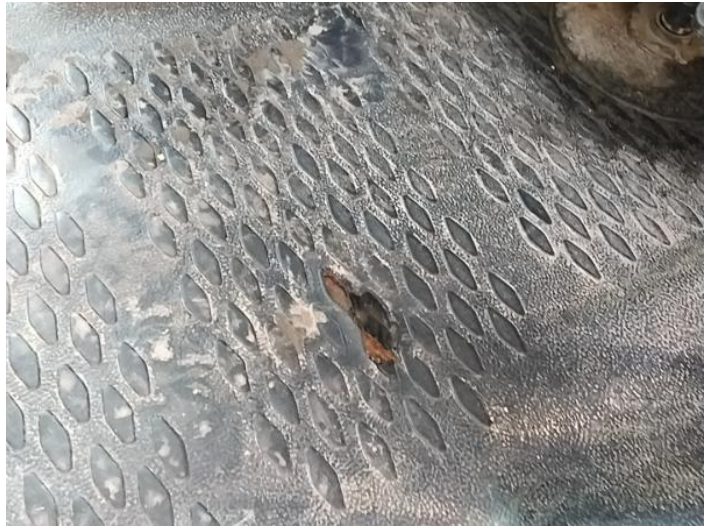
10: Carpets Front
Holed
Over 3mm

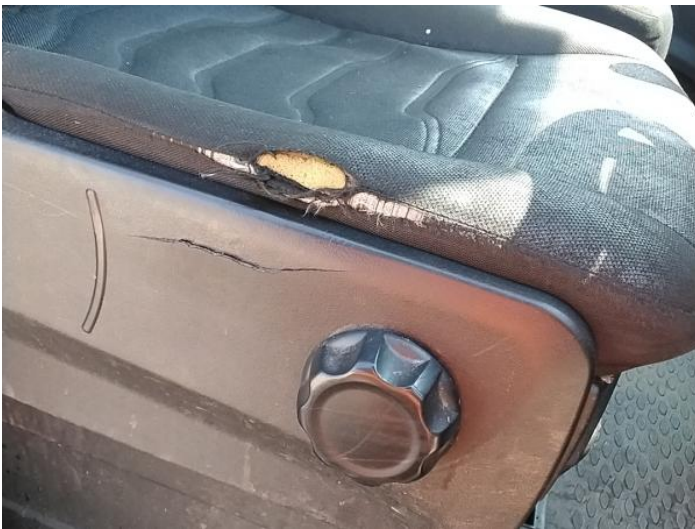
11: Seat Base Cover osf
Torn
Over 3mm
