VEHICLE INSPECTION REPORT

VX16AEC

Dennis Elite 6

Body Style Refuse Collector

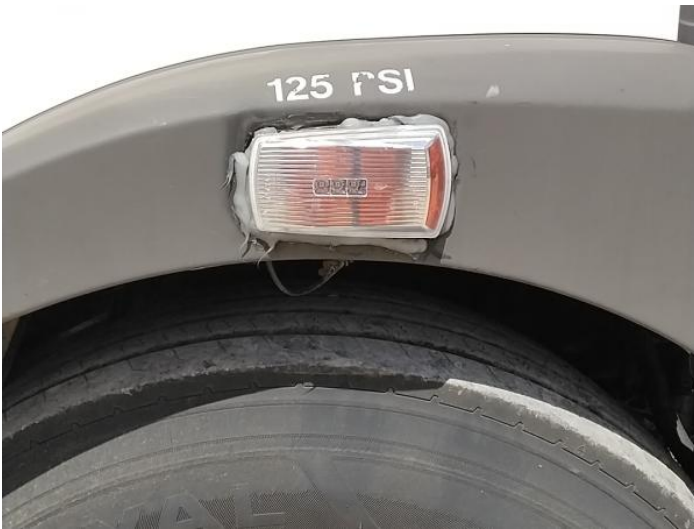
9: Flasher Side Repeater ns
Broken
Replace

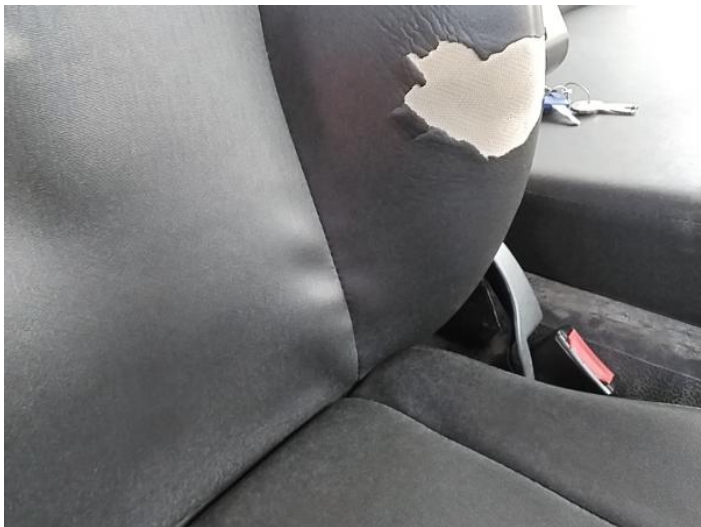
15: Seat Back Cover osf
Torn
Over 3mm
